92133  
Bill Billings  
T-Rex Dinosaur.  
1991  
Metal/Steel, Concrete, Mixed Media

## CONDITION REPORT

Examined by Francis Toohey  
17 Mar 2022

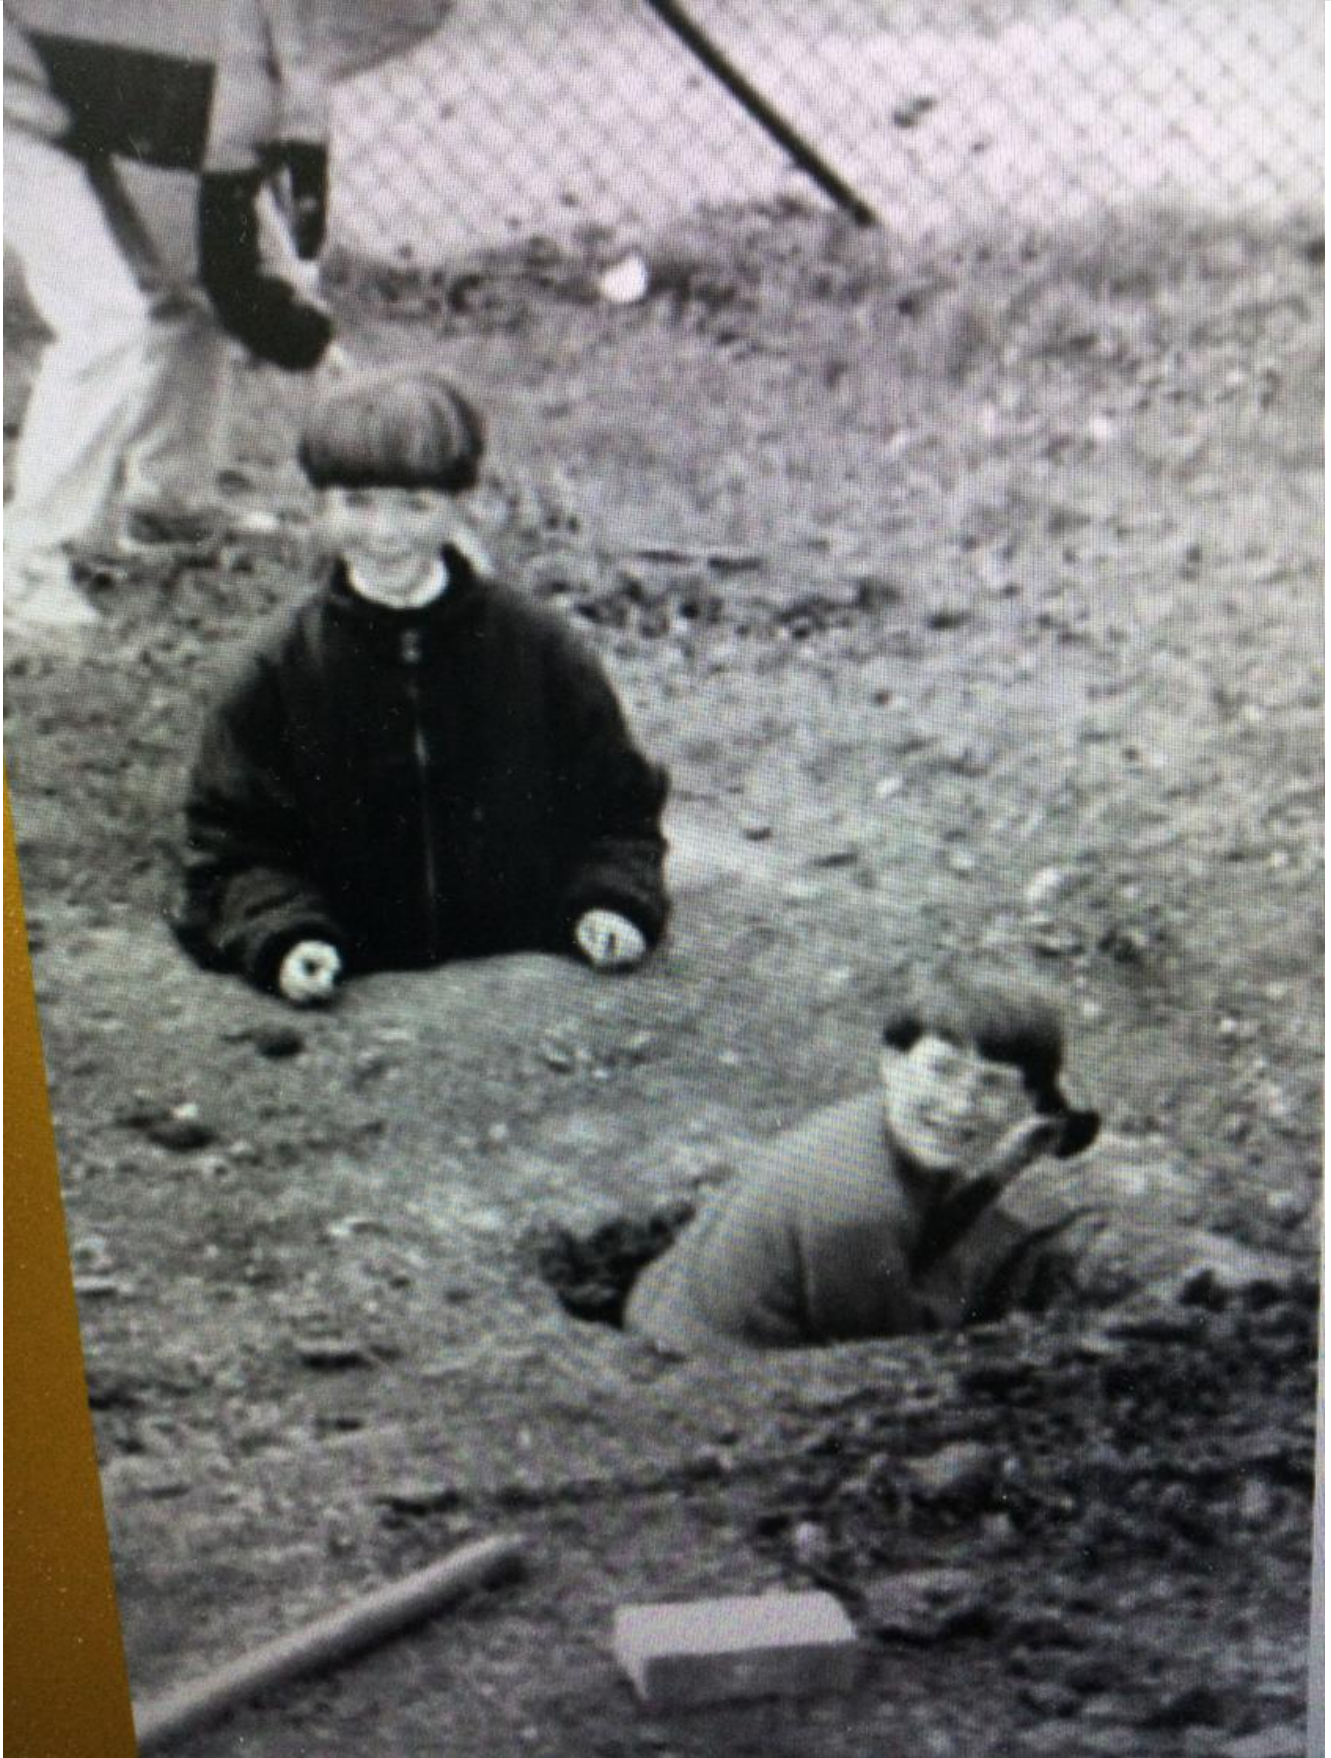
1. Image 8 Foundation preparation. / 21 Mar 2022

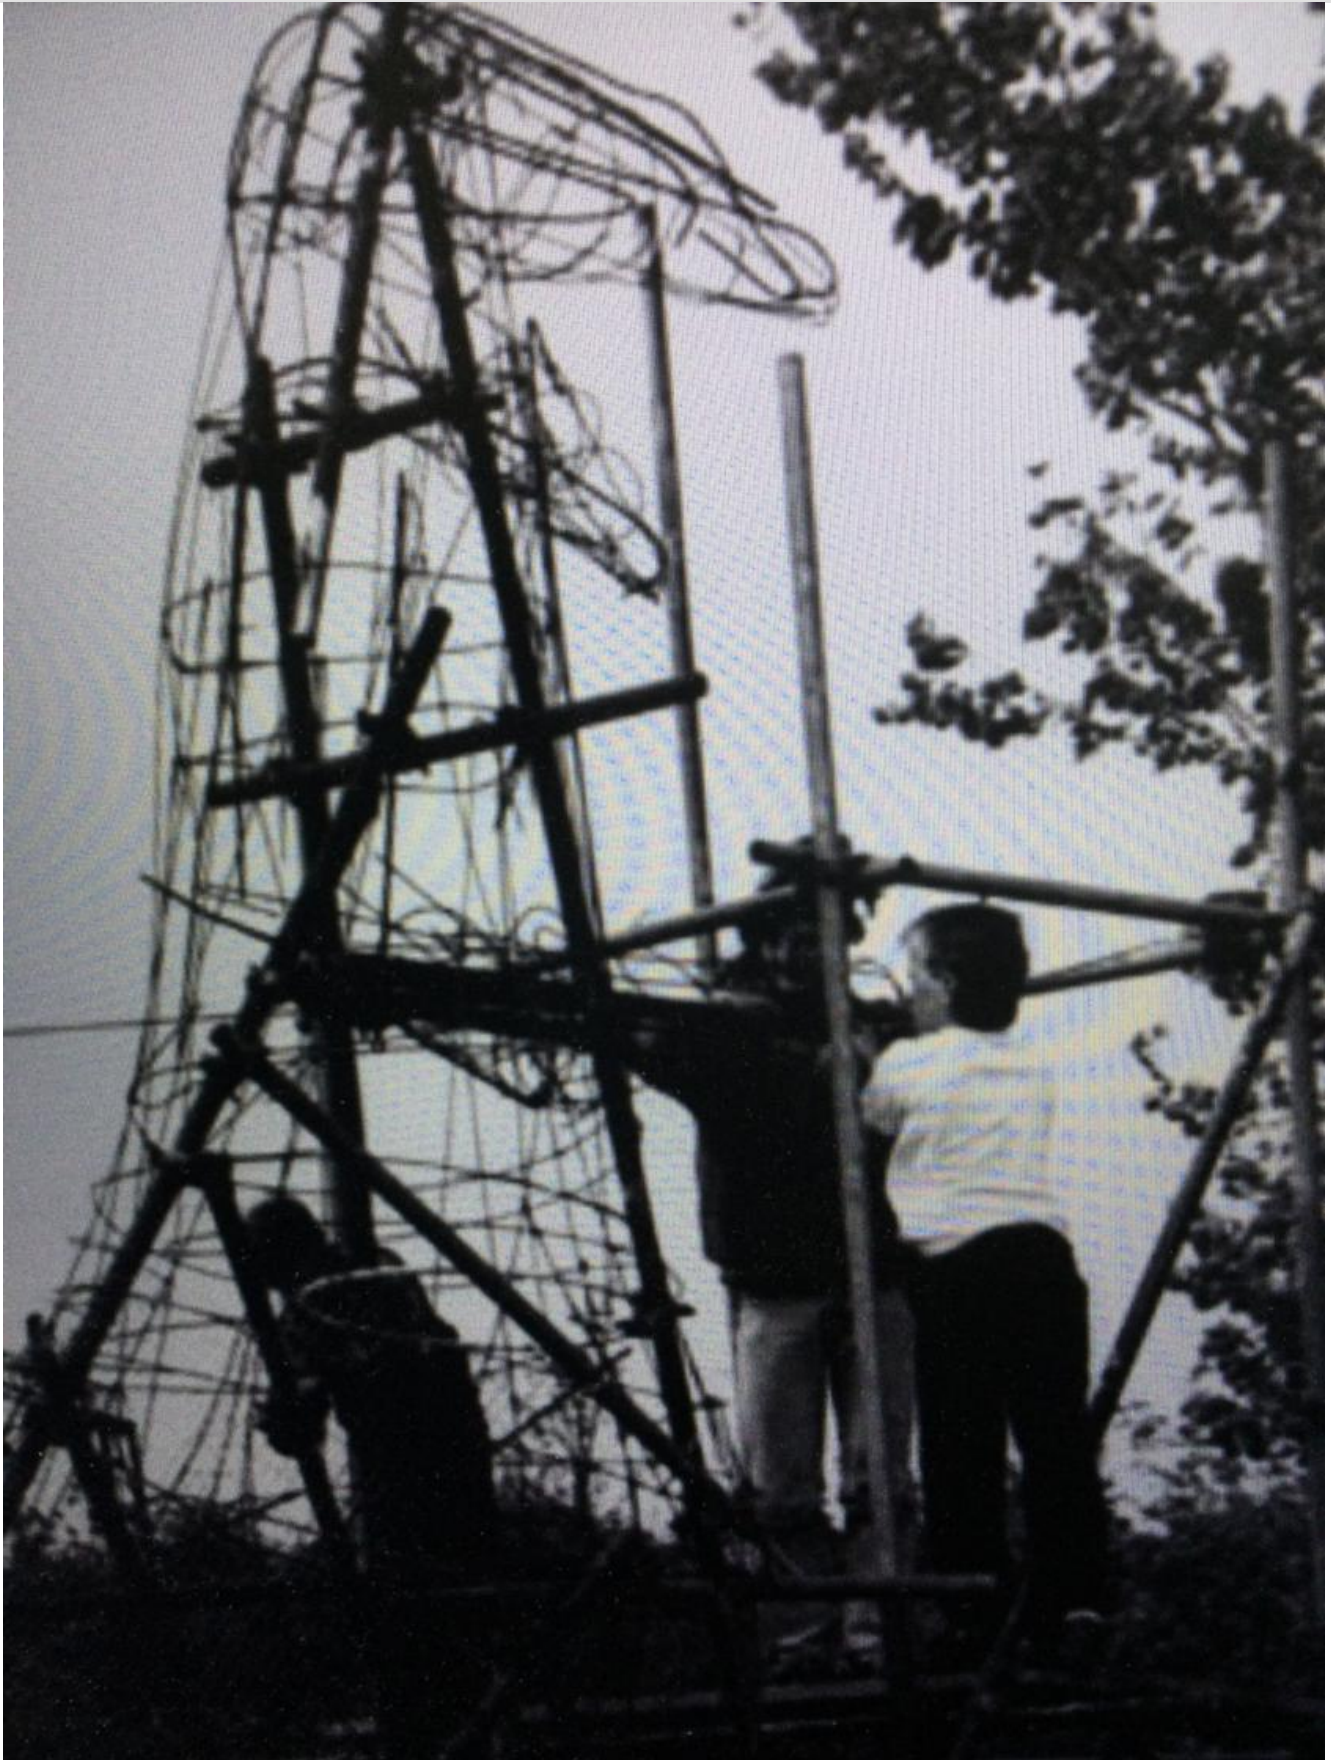
7. Image 2 Scaffold pole and wire construction. / 21 Mar 2022

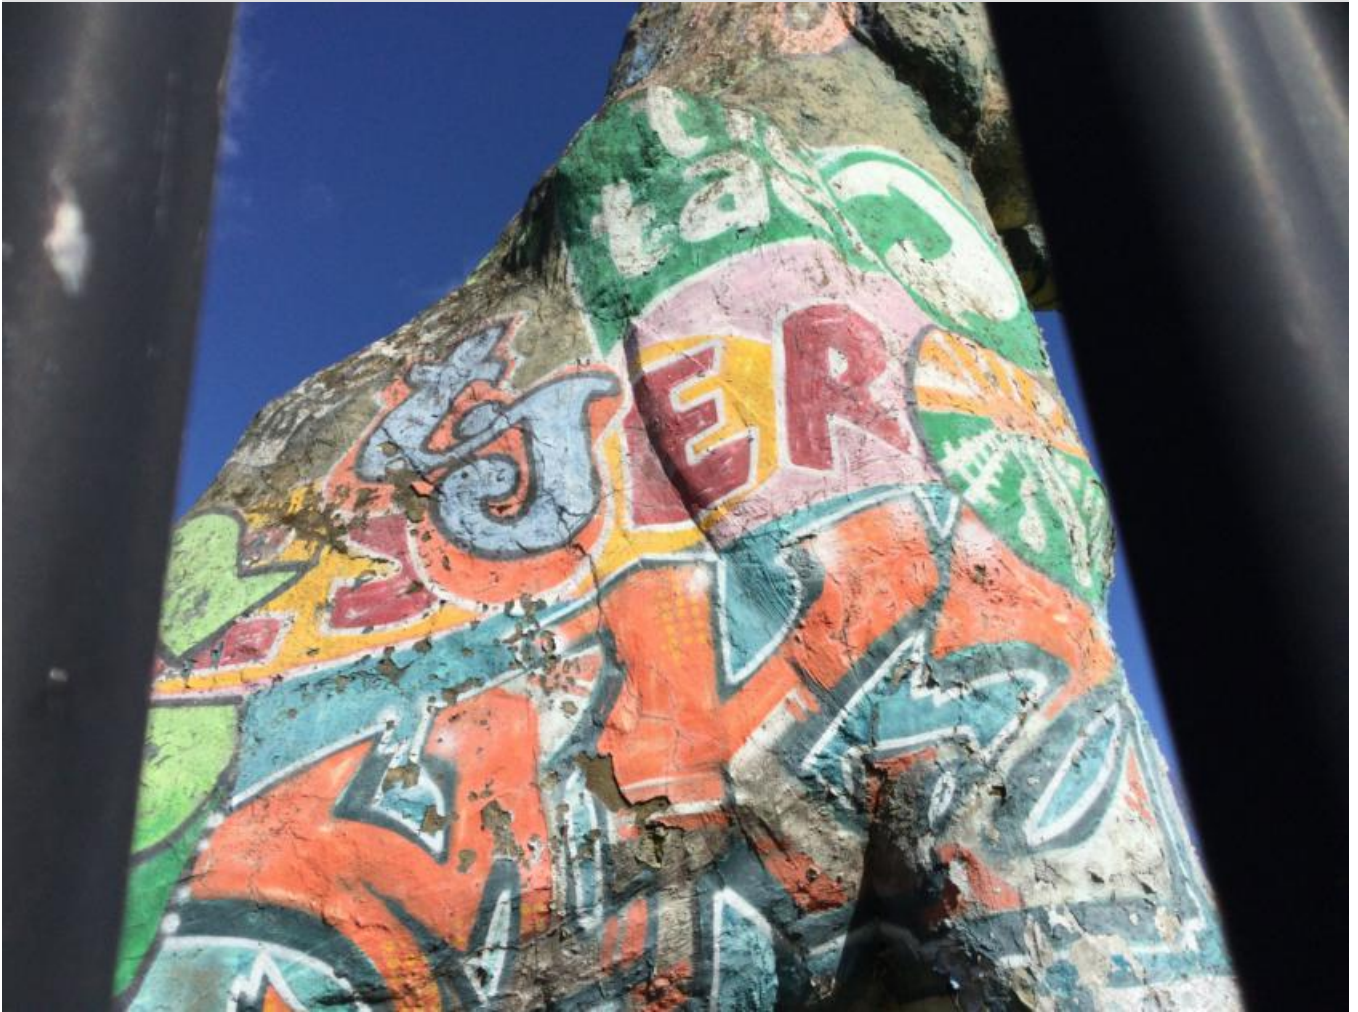
13. Image 14 Fissures Graffiti / 21 Mar 2022

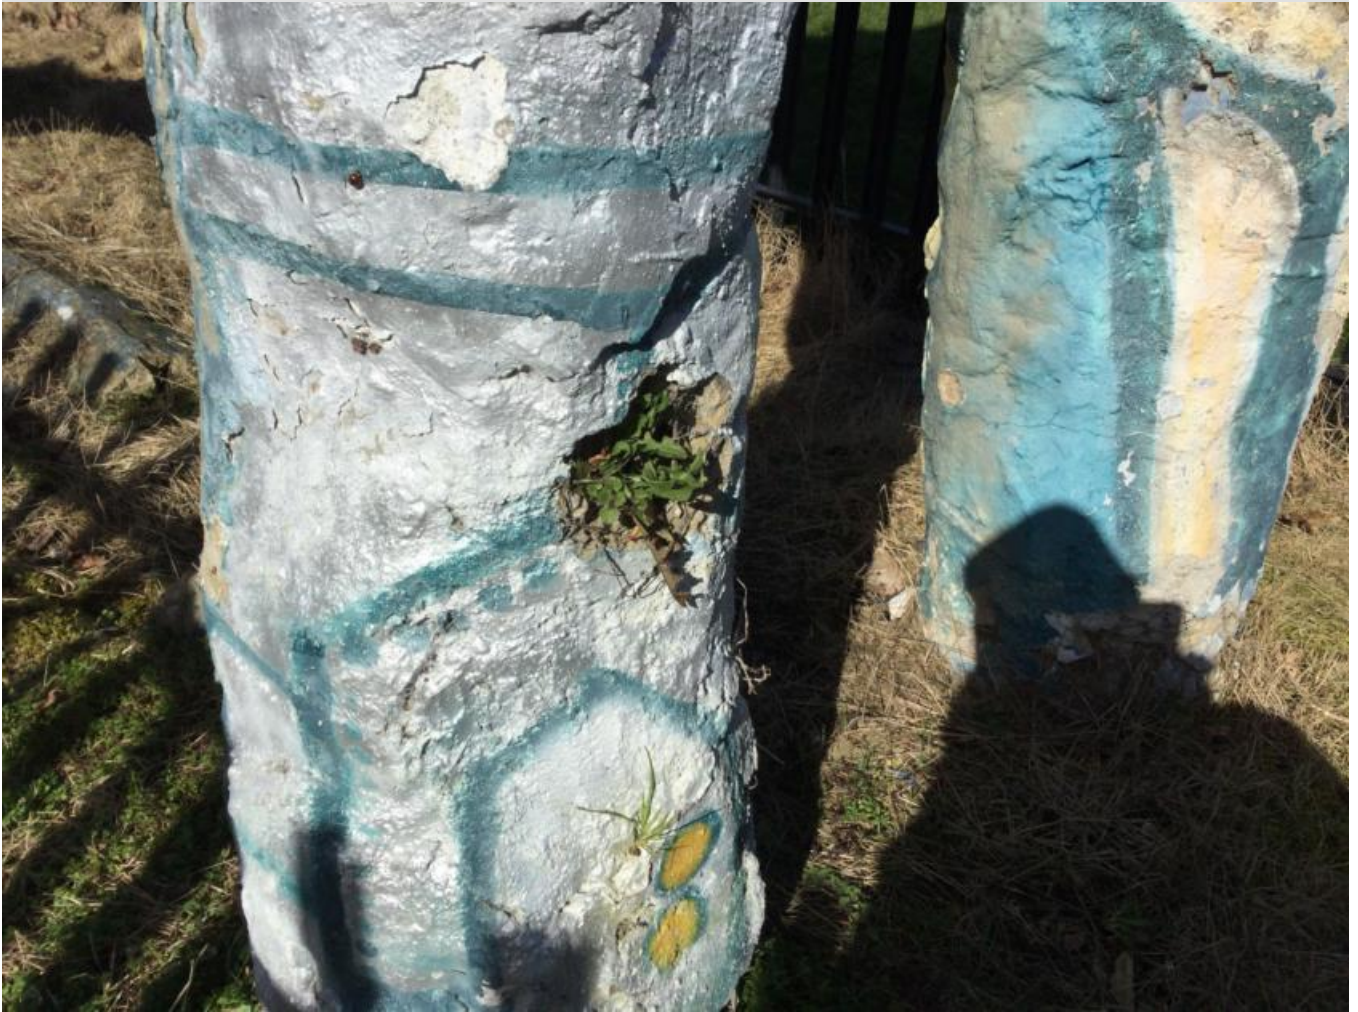
The front right leg has a 120mm hole just below the knee. At ground level on the same leg, there is a 150mm x 100mm loss to the concrete surface exposing wires.

The front right leg has a 300mm x 100mm repair to the concrete at the front just below the right knee.

14. Image 15 Front Right Leg. / 21 Mar 2022

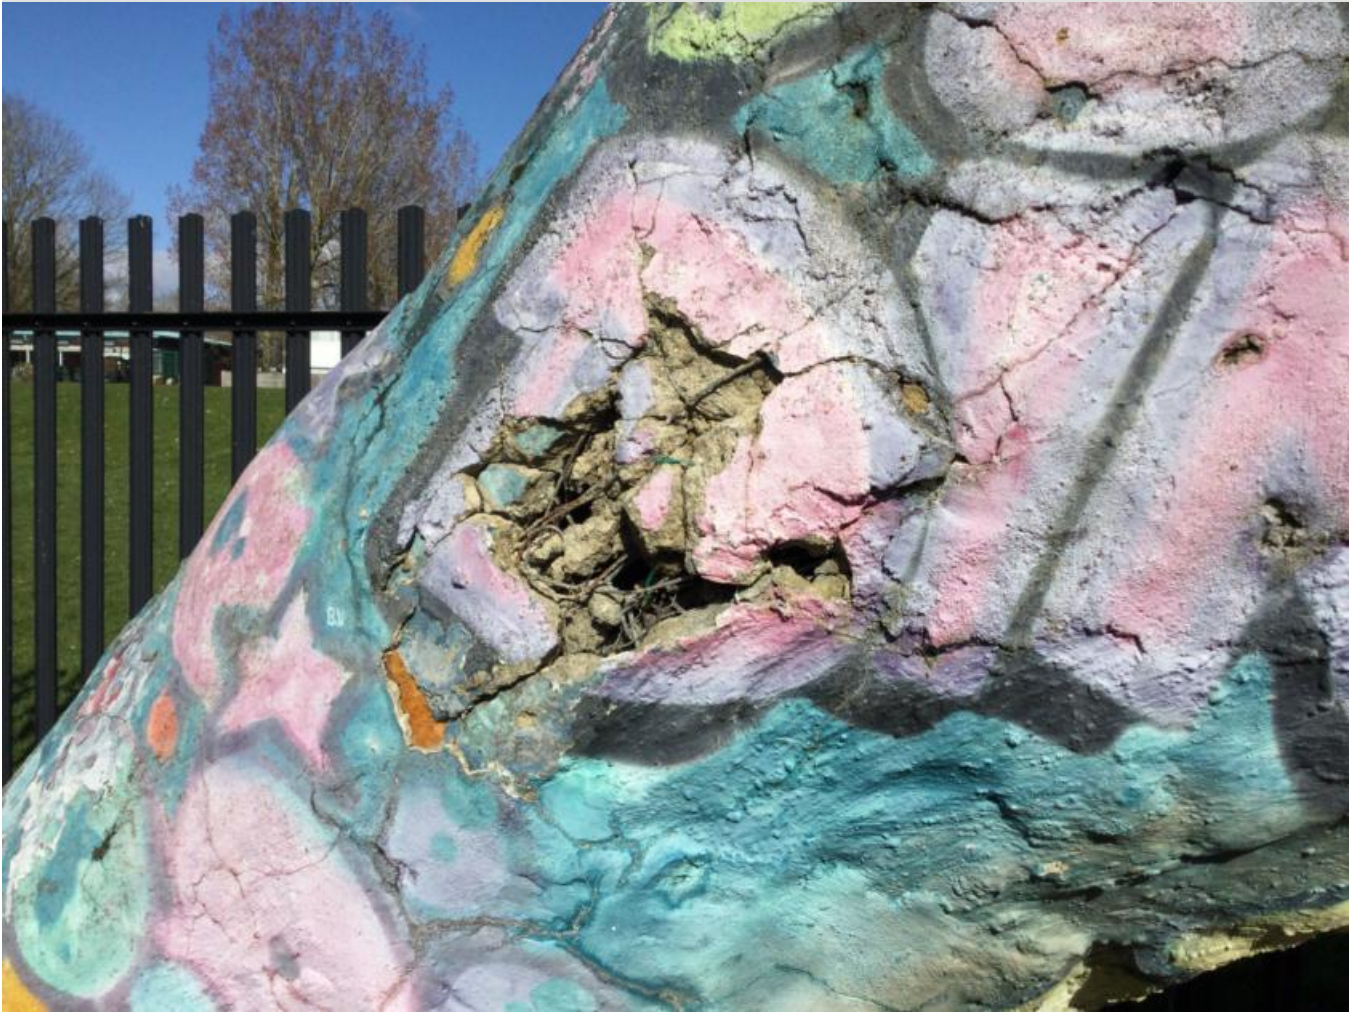
The proper right side elevation snout and teeth have rust staining indicating rusting to the internal mesh or armature. The right front claw is spalling away probably the result of rust expansion to the armature. The right flank of the torso has an area of cracked crazing. About 1.4 metres from ground level there is a serious loss of surface exposing the interior mesh. The wire mesh is galvanised but in places, the galvanised surface has failed and the mesh is rusting. The concrete surface is heavily crazed. This area is probably under stress due to the design. This crazing is probably the result of long term differential movement between steel and armature, steel mesh and concrete skin.

17. Image 18 Right Elevation. / 21 Mar 2022
