## **ARTiFACTS** - Conservation Report

Leon School and Sports College  
T-REX. Bill Billings, 1991

22 October 2007

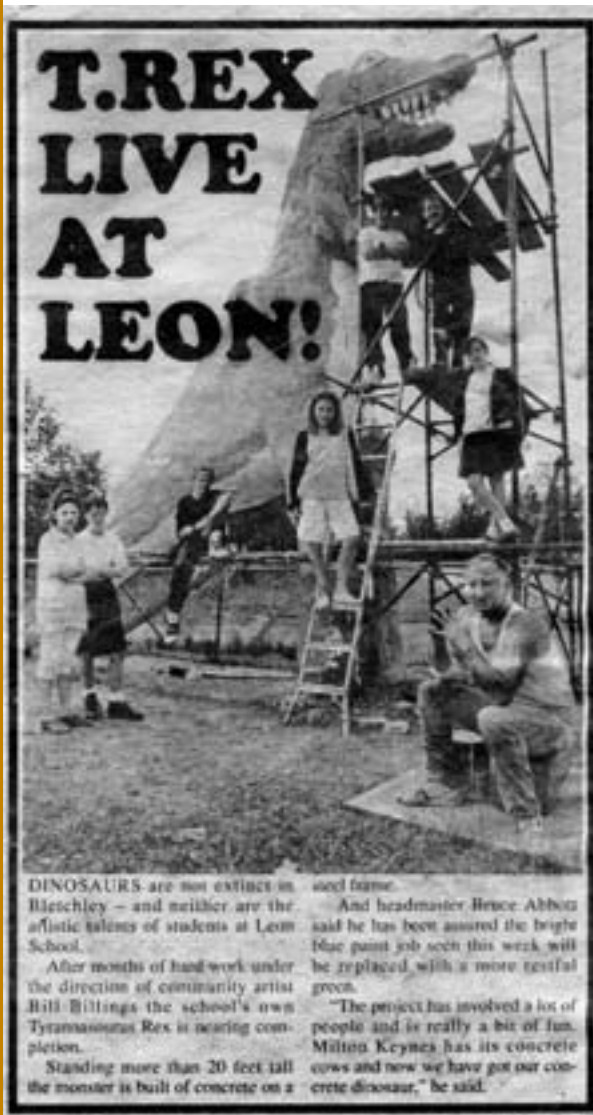
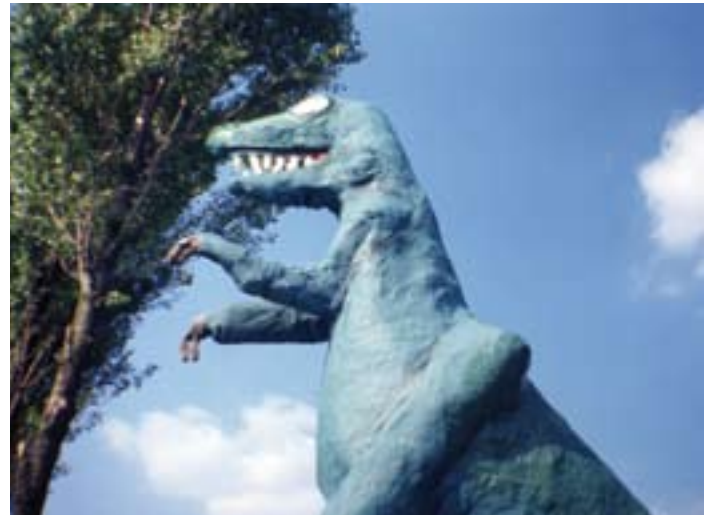
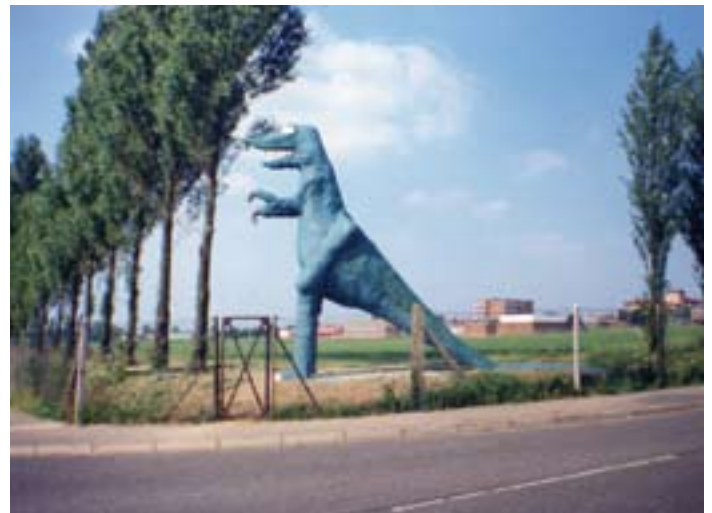
Pictures B. Billings archive (1991)

The Dinosaur (T-REX) was produced by Bill Billings in 1991, working with young people from Leon School. The project was commissioned as part of a children's workshop where pupils were invited to create model dinosaurs from Plasticine. One of the models was chosen and faithfully sculpted in the corner of the school playing field. It was designed to be seen from the railway line passing to the north. At approx. 20 ft. high x 28 ft. in length the T-REX is Milton Keynes' first landmark from rail. The original concept for the piece was not to be rendered but Ivy grown around the form creating a living sculpture. This never happened due to vigerous weedkilling from (the then) Bucks County Council.

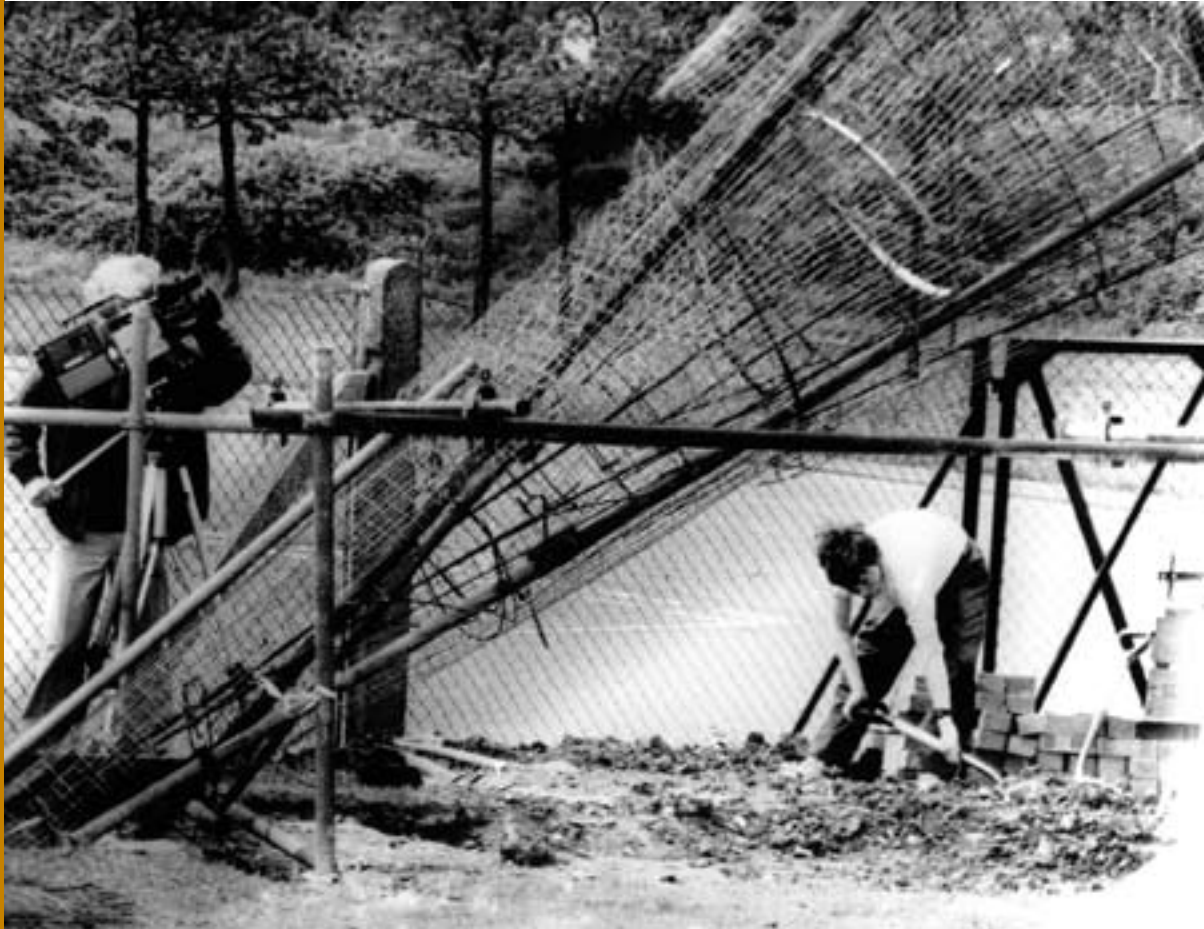
The Dinosaur (T-REX) was created with the assistance of many young people from the estate and the school. The following archive photographs from the project clearly show Bill working alongside and supervising the project. The following photographs give us a clear understanding of the structure and strength given to T-Rex whilst it was being built.

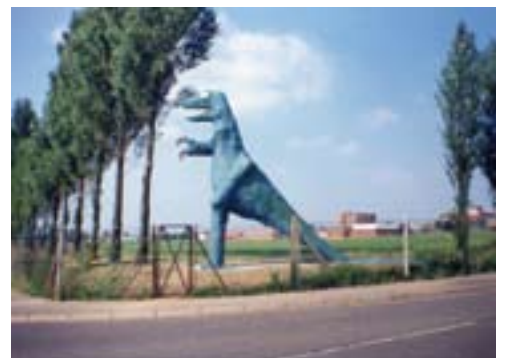
T-REX. Bill Billings, 1991

The project was completed in July 1991, painted in blue/green, with facial details of white eyes and red eyeballs, white teeth, red gums, brown claws on the arms and white claws on the feet.
